Integrated Maritime Risk Management

Managing Vertical and Horizontal Clearance from Keel to Mast

Case Study 1: Savannah: Savannah: A Narrow River, A Big Bridge, and Bigger Ships

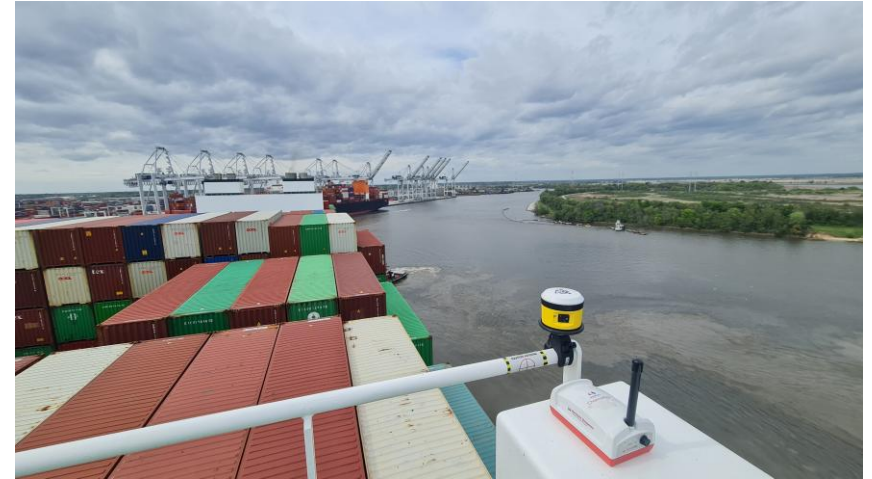
To start, we undertook vessel motion measurements to determine the real UKC between the seabed and the vessel keel

Measuring vessel motions near the berths

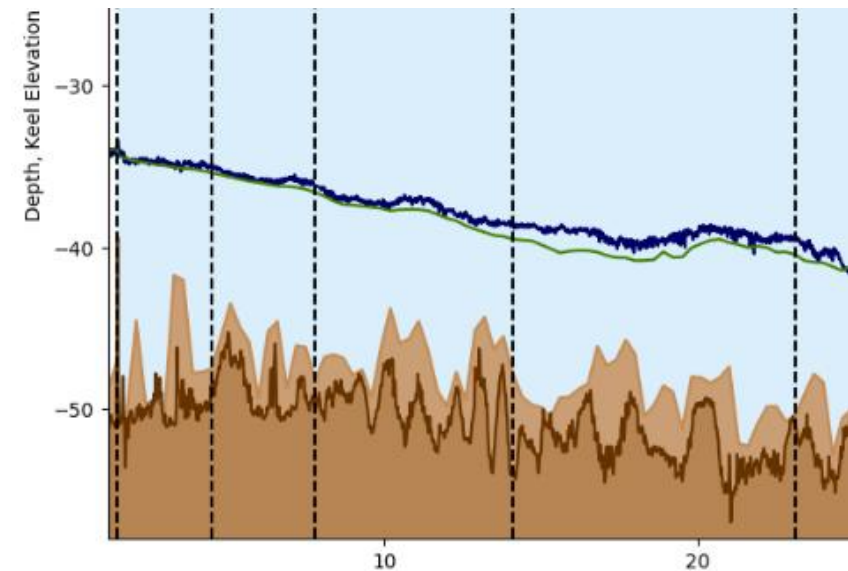
Measured keel elevation vs channel depth and depth under keel

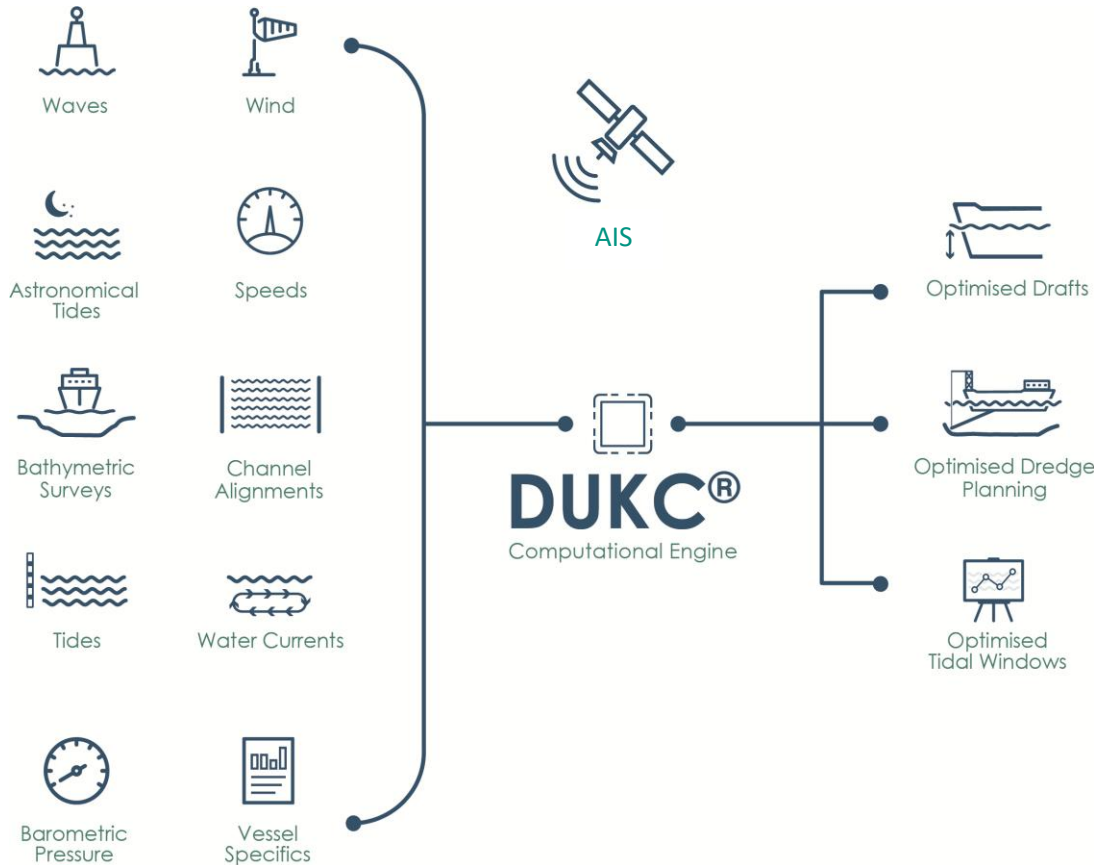
We built a custom DUKC® that incorporated the real-time and forecast water density, water currents, tides, air gap, vessel speeds, and bathymetry.

Combining the weather and vessel models, latest bathymetry, and air gap clearance gives optimised operational windows and reduces risk of incidents due to the reduction in unknowns and increased situational awareness.

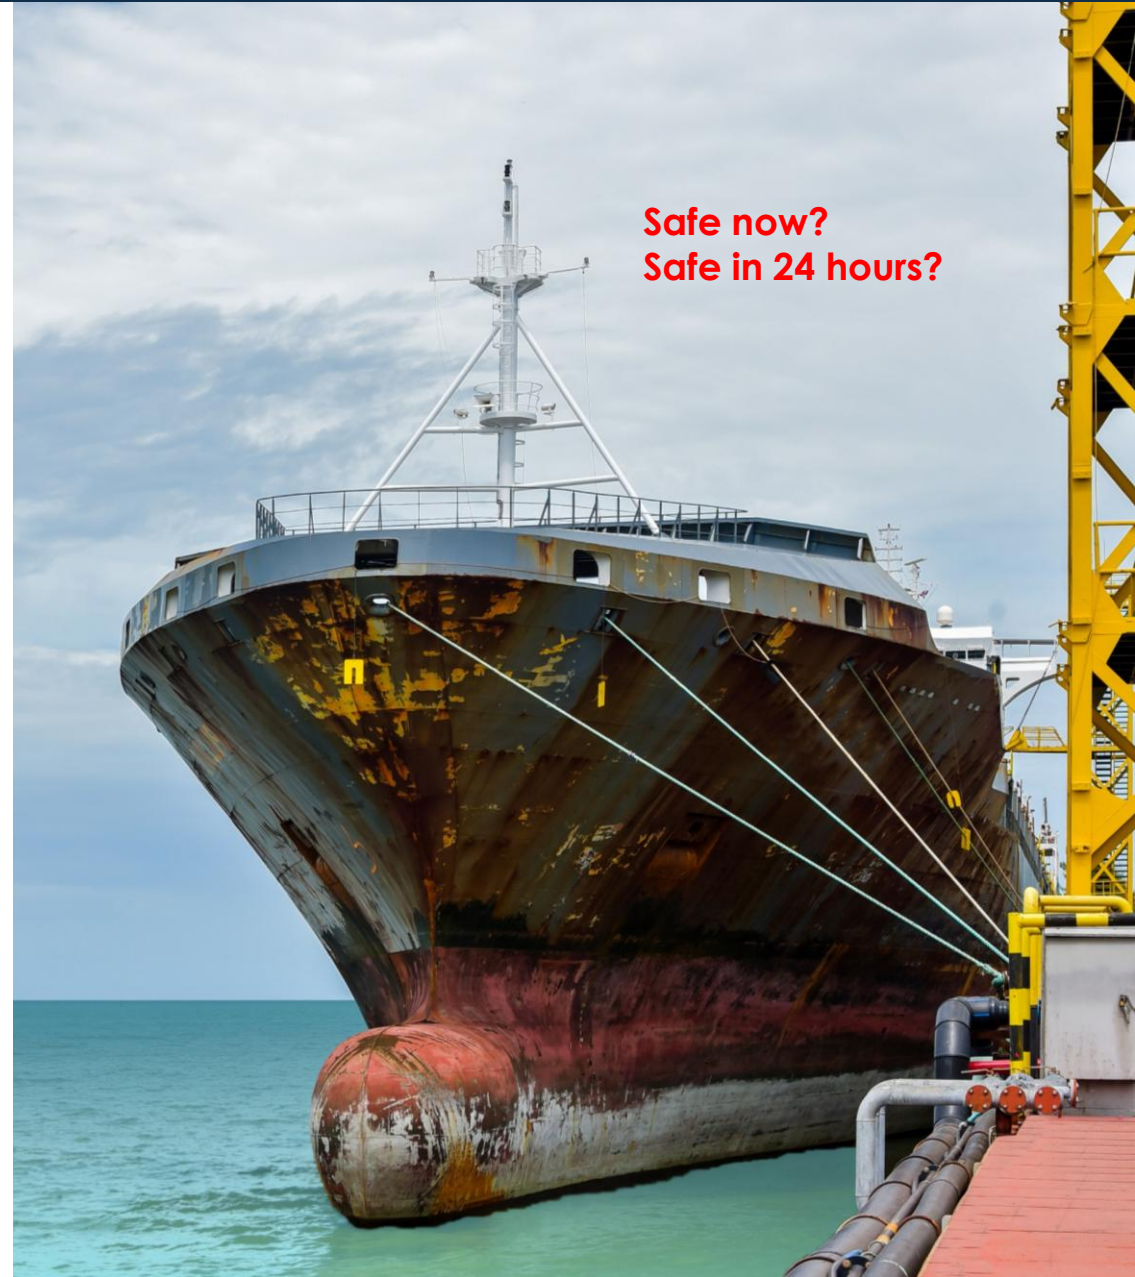
The client is a bulk export port with berths exposed to open-ocean conditions, where significant vessel motions at berth were being experienced.

They needed a clearer way to understand berth-side risk - distinguishing situations where it was genuinely unsafe to remain alongside from those where conditions appeared uncomfortable but were still within safe limits.

Unnecessary de-berthings were costly, but so too was the risk of mooring line failure or injury to personnel.

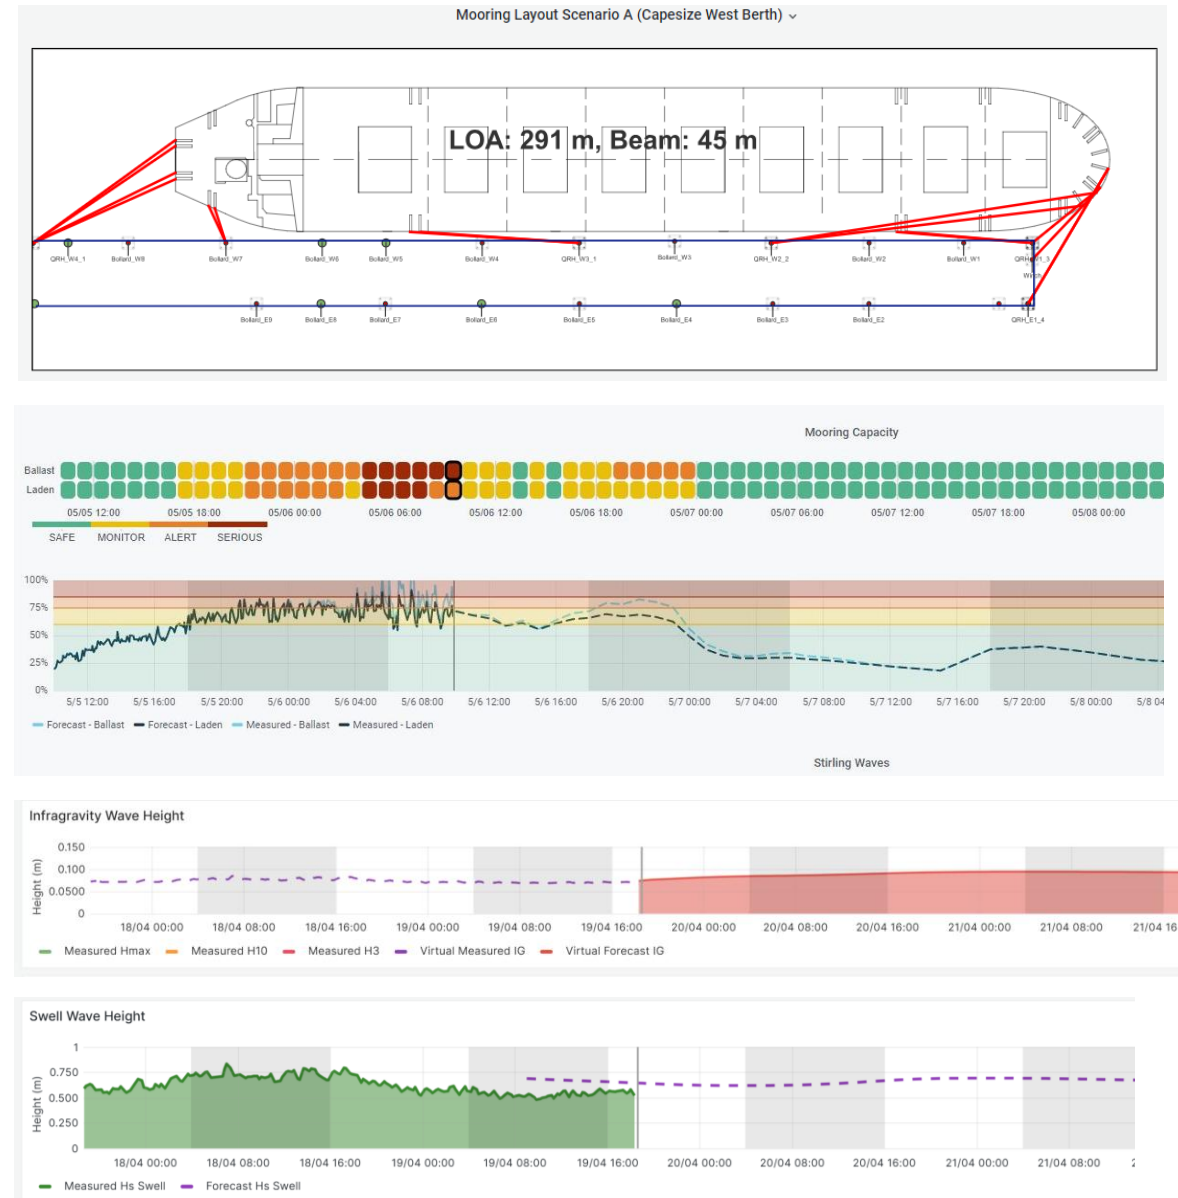
A swell exposed berth: The solution

Dynamic Mooring Analysis - Custom models for their berths, vessels, load states and mooring scenarios. Identified **Infragravity Longwaves (IG)** as a driving factor in risk of vessel motions at berth.

Implement stand-alone IG sensors at the port to better detect and forecast these long waves – hard to see, strong effect on vessel motions alongside

Live berth warning system incorporating the mooring models and real-time/forecast weather conditions

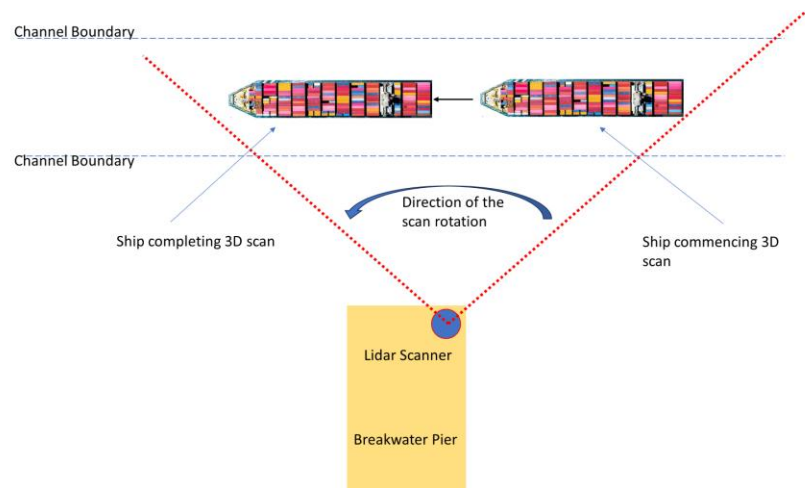
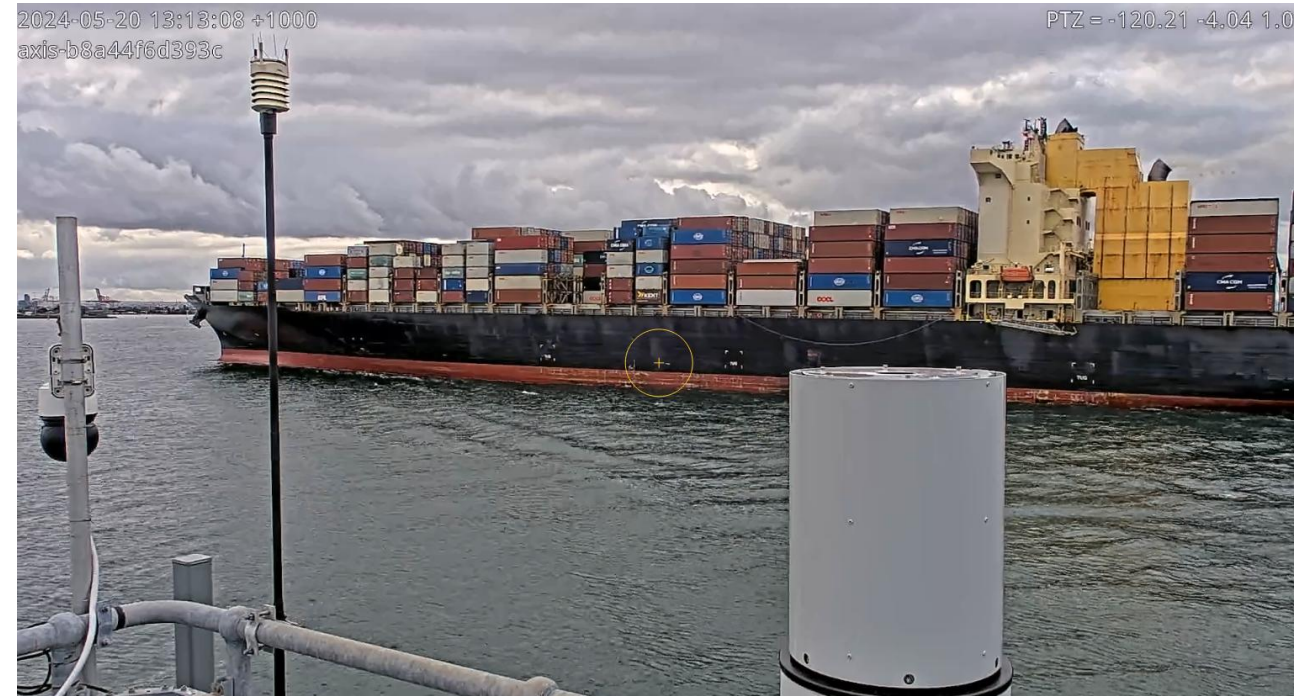
- Collaboration project between OMC and Ports Victoria
- Hardware solution using Lidar (Light Detection & Ranging) scanners to create a point-cloud representation of a vessel
